KAIZEN CARD

AREA	BMW	Plant:	TUPELO USA
KAIZEN THEME	Not Seating Clip Cramp

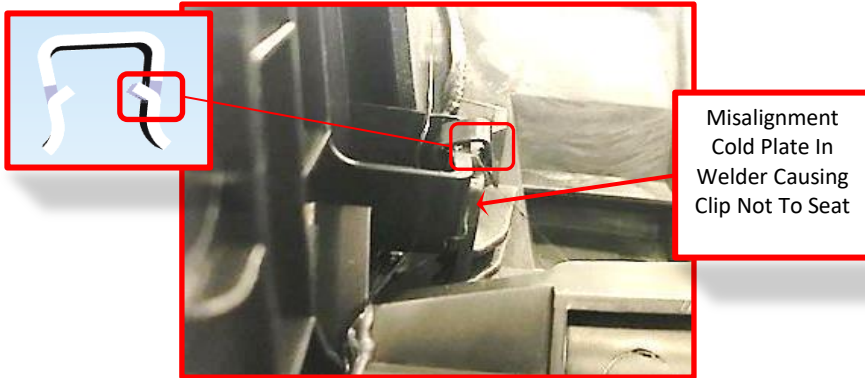
Before Kaizen Description:	Misalignment in cold plate to carrier causing clip cramp not to properly seat. (Minimized weld/pull test force)
-----------------------------------	---
