AREA	BMW	Plant:	TUPELO USA
KAIZEN THEME	Quality

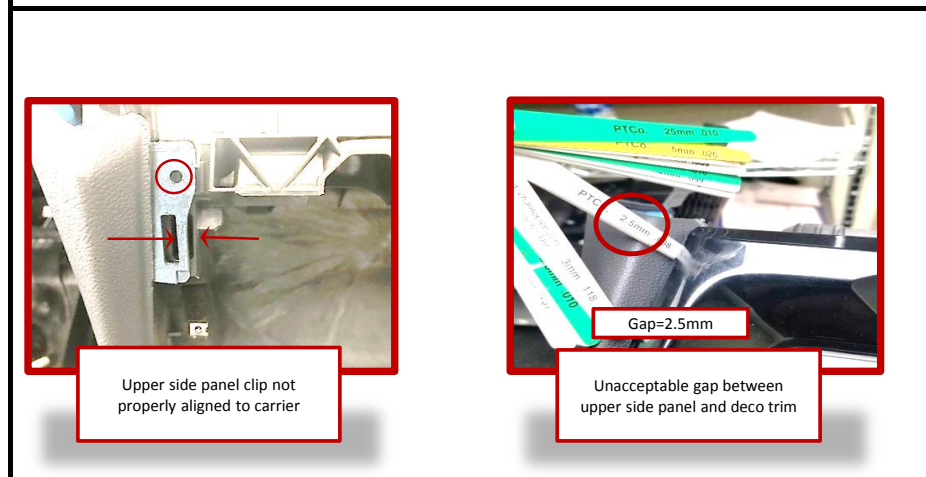
Before Kaizen Description:	Unacceptable gap exposed after the installation of deco trim to the center console on G01 parts coming from welder 2A
----------------------------	---
